ROCKFALL HAZARD ASSESSMENT AND GEOLOGICAL-GEOTECHNICAL CHARACTERIZATION OF A ROCK SLOPE IN BR-356

This article presents a rockfall hazard assessment and a geological-geotechnical characterization of a slope located in BR-356, between the km 72 and 74 of the road, in the town of Ouro Preto, state of Minas Gerais, Brazil. The BR-356 highway is located in the states of Minas Gerais and Rio de Janeiro, and can be considered a strategic highway for the flow of materials and passengers, promoting the economy and mobility in Brazil. As it is an alternative link between the metropolitan area of Belo Horizonte and the northwestern region of Rio de Janeiro, a slope on a stretch of BR-356 highway was chosen for geological-geotechnical characterization and hazard analysis for the rockfall.

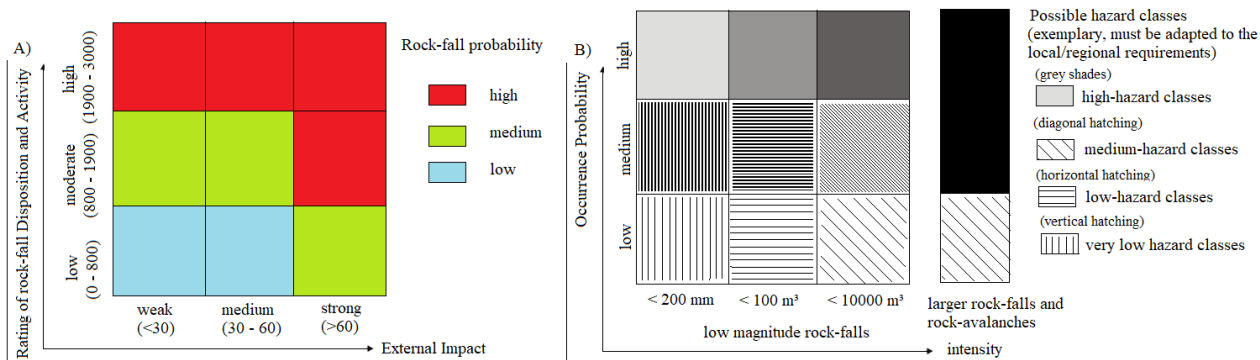
Figure 2: A) Rockfall probability matrix e B) Rock-fall hazard matrix (adapted by Bauer and Neumann, 2011).

Table 8 presents the probability of occurrence of rockfall in the analyzed slope. The maximum probability is represented by the rainy periods and the minimum probability is represented by the dry periods. The probability of rockfall occurrence was given by the probability matrix presented in Figure 2a.

Knowing the probability of rockfall and the intensity of the event for the slope, it was possible to classify its hazardous degree. This result was obtained by means of the hazard matrix of Figure 2B given above and presented in Table 9.

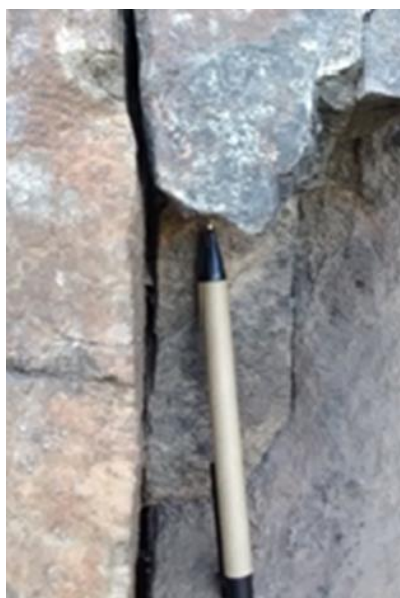
Figure 3: Apertures in the discontinuities present in the rock mass.

Figure 3 presents the image of part of the slope where it is possible to evaluate the parameters related to the discontinuities, such as aperture, filling and roughness of the rock mass. Apertures of the discontinuities between the values of 1 and 5 millimeters were identified,

with no filling. Regarding the roughness, it was concluded that the discontinuities in rock mass presents a slight roughness.

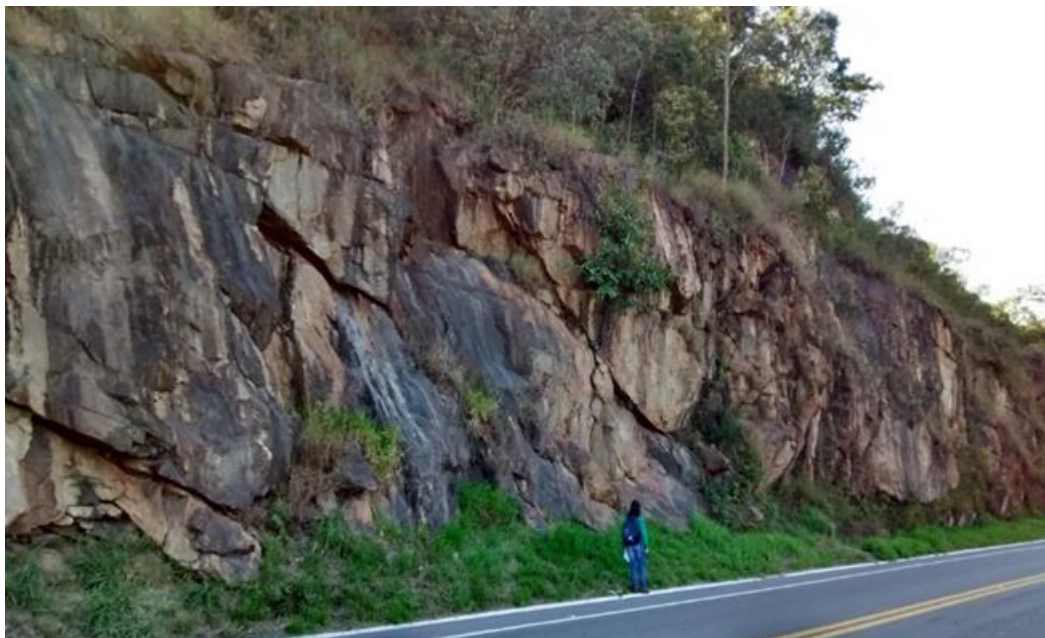
Figure 4: Slope study in the Rodovia dos Inconfidentes (BR-356) with highlight for the formation of blocks.

The basic parameters for the geotechnical characterization of the rock mass were collected in the field. The basic Rock Mass Rating was determined in order to allow a classification for the rock mass that composes the slope studied. Figure 4 presents the slope studied and allows to observe the distribution of discontinuity families giving rise to the blocks of rock present in the rock mass. Another important point to observe in Figure 4 is the proximity between the highway and the slope.

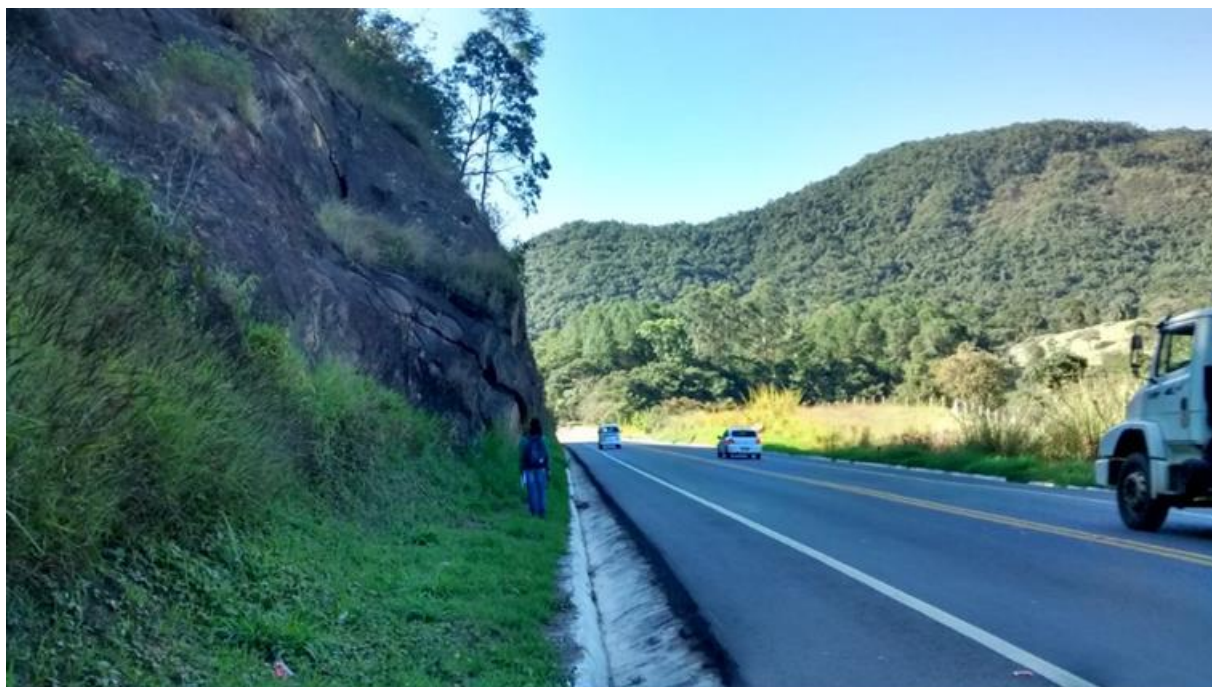
Figure 5: Marginal slope to BR-356 highway with its discontinuities.

The parameters that most influenced the susceptibility to rockfall in this slope was a favorable orientation to the formation of blocks and signs of activity. The signs of activity were identified directly in the field, from fallen blocks, fractures in the rock mass, open and displaced joints and presence of vegetation between the discontinuities. Figure 5 shows the studied slope, as well as its discontinuities.
